PlainsTalk

News from the Missouri Basin & Arkansas-Rio Grande-Texas Gulf Regions

Winter 2020/2021

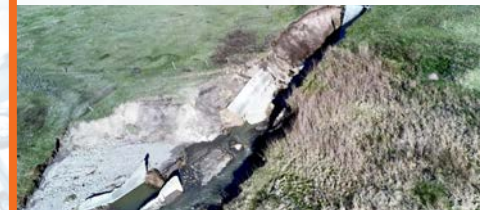
May 17, 2020

On May 17, 2020, the last of a series of five concrete drop structures (Drop 5) failed on Reclamation's St. Mary Canal, located in northern Montana and within the Blackfoot Indian Reservation. No injuries occurred as a result of this failure, and canal flows were shut off. Drop 5 is approximately 250-ft long and is at the end of the 29-mile long canal. The structure is one of five drop structures that provide for an elevation decrease of over 200 feet before the water is discharged into the North Fork Milk River.

Reclamation assembled a joint technical team to assess the situation and determine the cause of the failure and recommend near and long-term repairs. The cause of the failure is believed to be the result of canal flows penetrating the concrete chute and causing erosion (voids) and buckling/collapsing of the concrete chute sections. The team identified two temporary solutions. However, upon evaluation these solutions may have only extended irrigation deliveries by six days if completed within optimistic schedules. In response the Milk River Joint Board of Control (MRJBOC) voted to not pursue temporary fixes and focus on immediately pursuing permanent repairs. Additionally, Drop 2 (upstream of Drop 5) was included since it was determined to be at high risk for failure and had previously been planned for replacement.

St. Mary Canal Drop 5 Repairs

Reclamation determined the project to replace Drops 2 and 5 to be qualified Emergency Extraordinary Maintenance (EXM), allowing 35 percent of the total costs to be non-reimbursable in accordance with P.L. 111-11. Users are responsible for 73.96 percent of remaining 65 percent of costs for the project under current allocations.

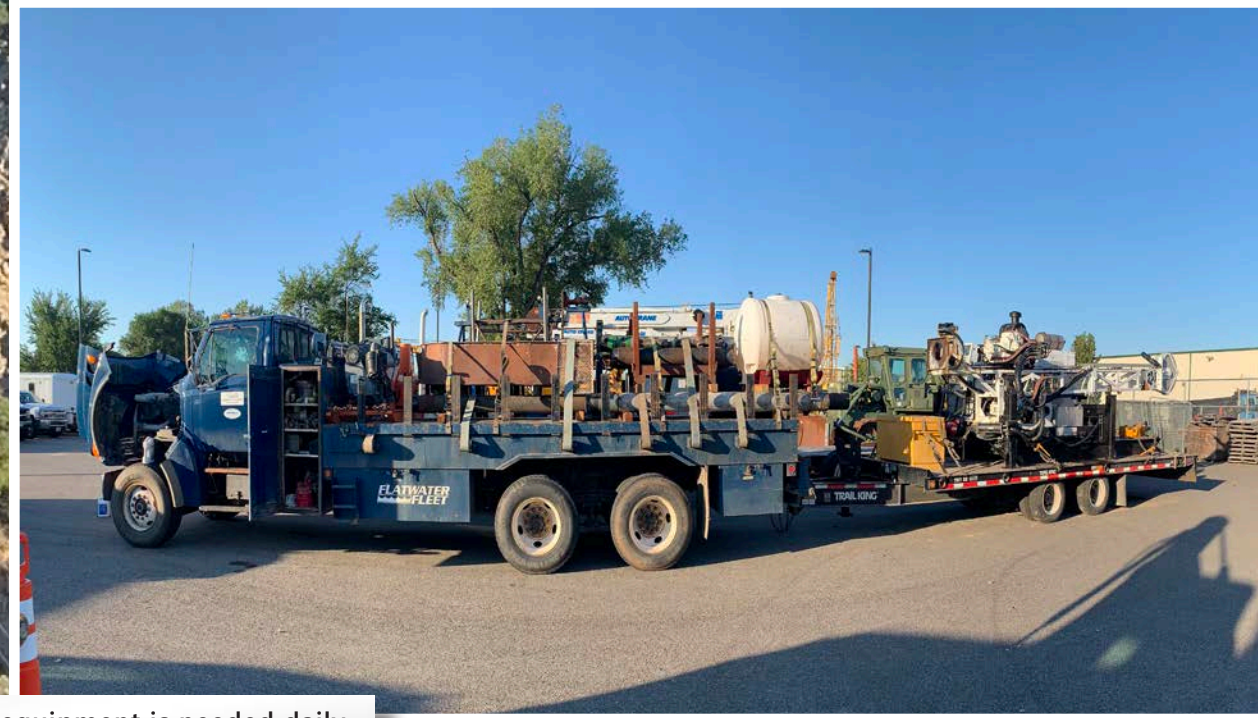
A typical load out and what type and how much equipment is needed daily. The LF70 skid drill rig is needed to do the drilling at Seminoe Dam due to the weight restrictions on the crest of the dam.

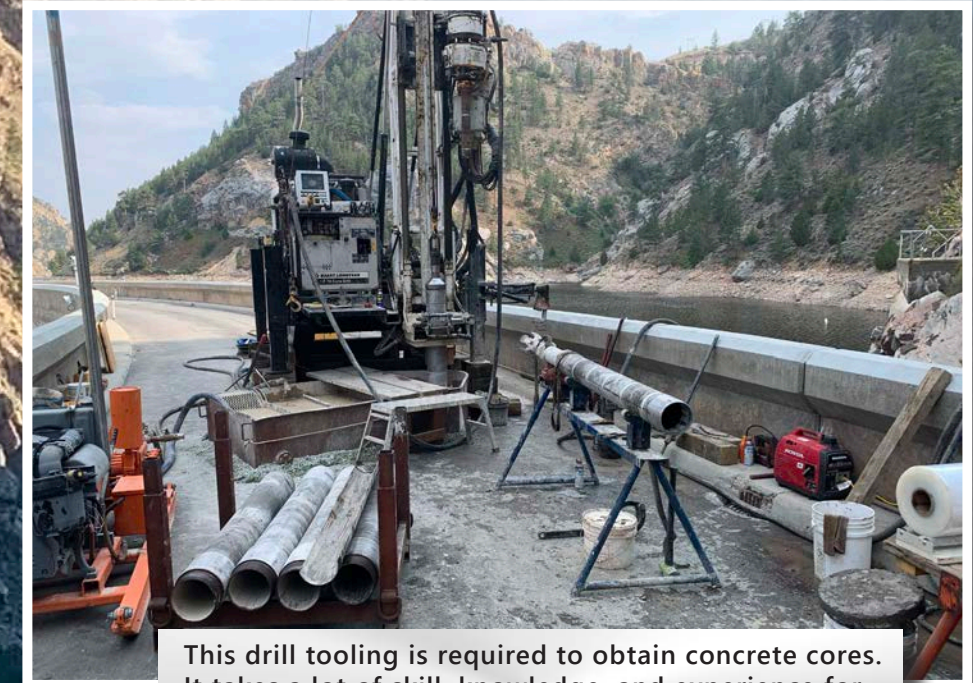
This drill tooling is required to obtain concrete cores. It takes a lot of skill, knowledge, and experience for the Drill Crew to do their job.

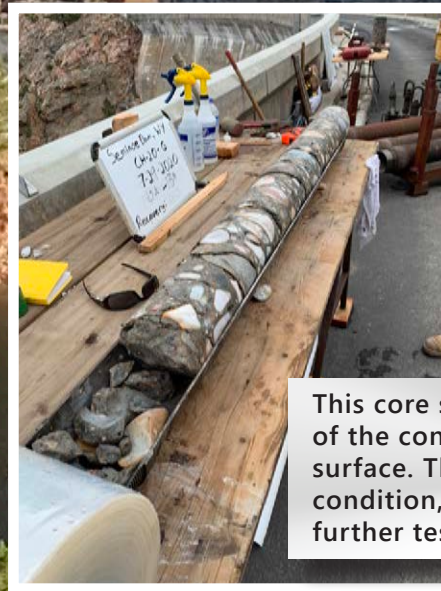
This core sample shows the condition of the concrete several feet below the surface. The geologist will document its condition, then it will be transported for further testing.

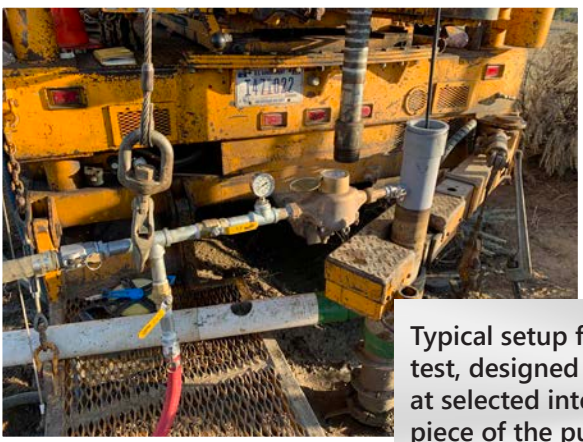
Typical setup for a single packer down staged permeability test, designed to test the water permeability of formations at selected intervals with various pressures. This is a valuable piece of the puzzle for engineers to determine how much water is moving in and around the abutment of the dam.

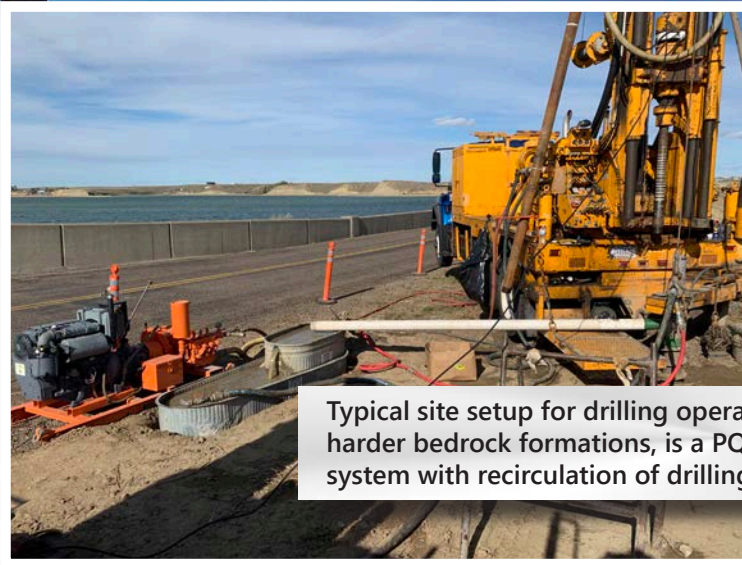
Typical site setup for drilling operations. This setup, which is used for harder bedrock formations, is a PQ3 wireline diamond core drilling system with recirculation of drilling fluids.

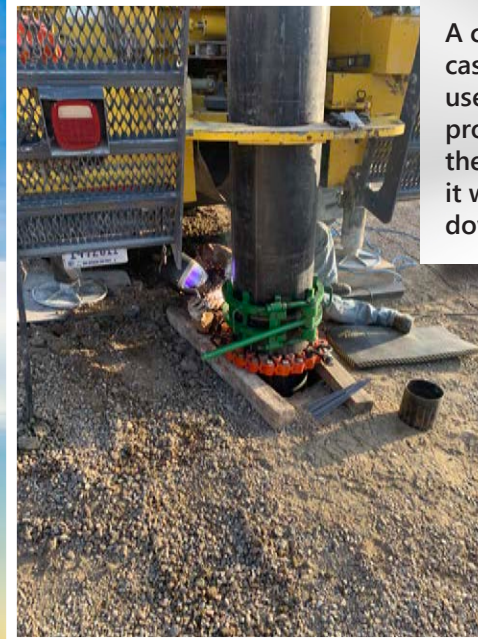
A crew member welds a 16 inch casing for a pump well. This well was used to determine hydrogeologic properties of the dam site, allowing the engineers to determine what it will take to safely excavate the downhill side of the dam.

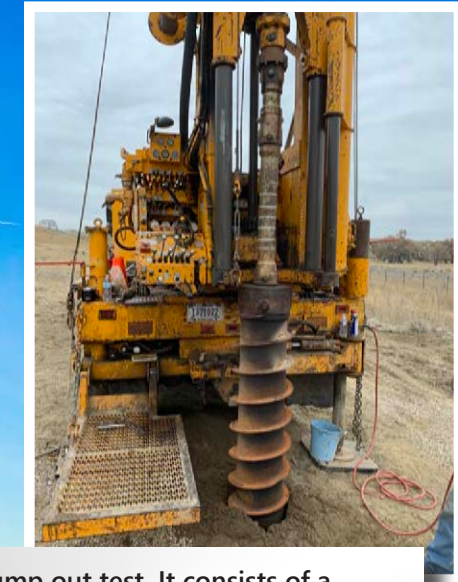
Typical setup for a pump out test. It consists of a submersible pump flowing at a constant rate. There are 8-10 surrounding wells with instrumentation recording the effects the pump rate is having on the surrounding drawdown of the aquifer. The engineers use this information to design a successful pump out program prior to construction.
